## **Oneida County SWCD**

# Stream Restoration in Oneida County

First major Natural  
Channel Design  
project in Oneida  
County on the  
Mohawk River;  
NYSDEC, USFWS, NYS  
Canal Corps, DOT

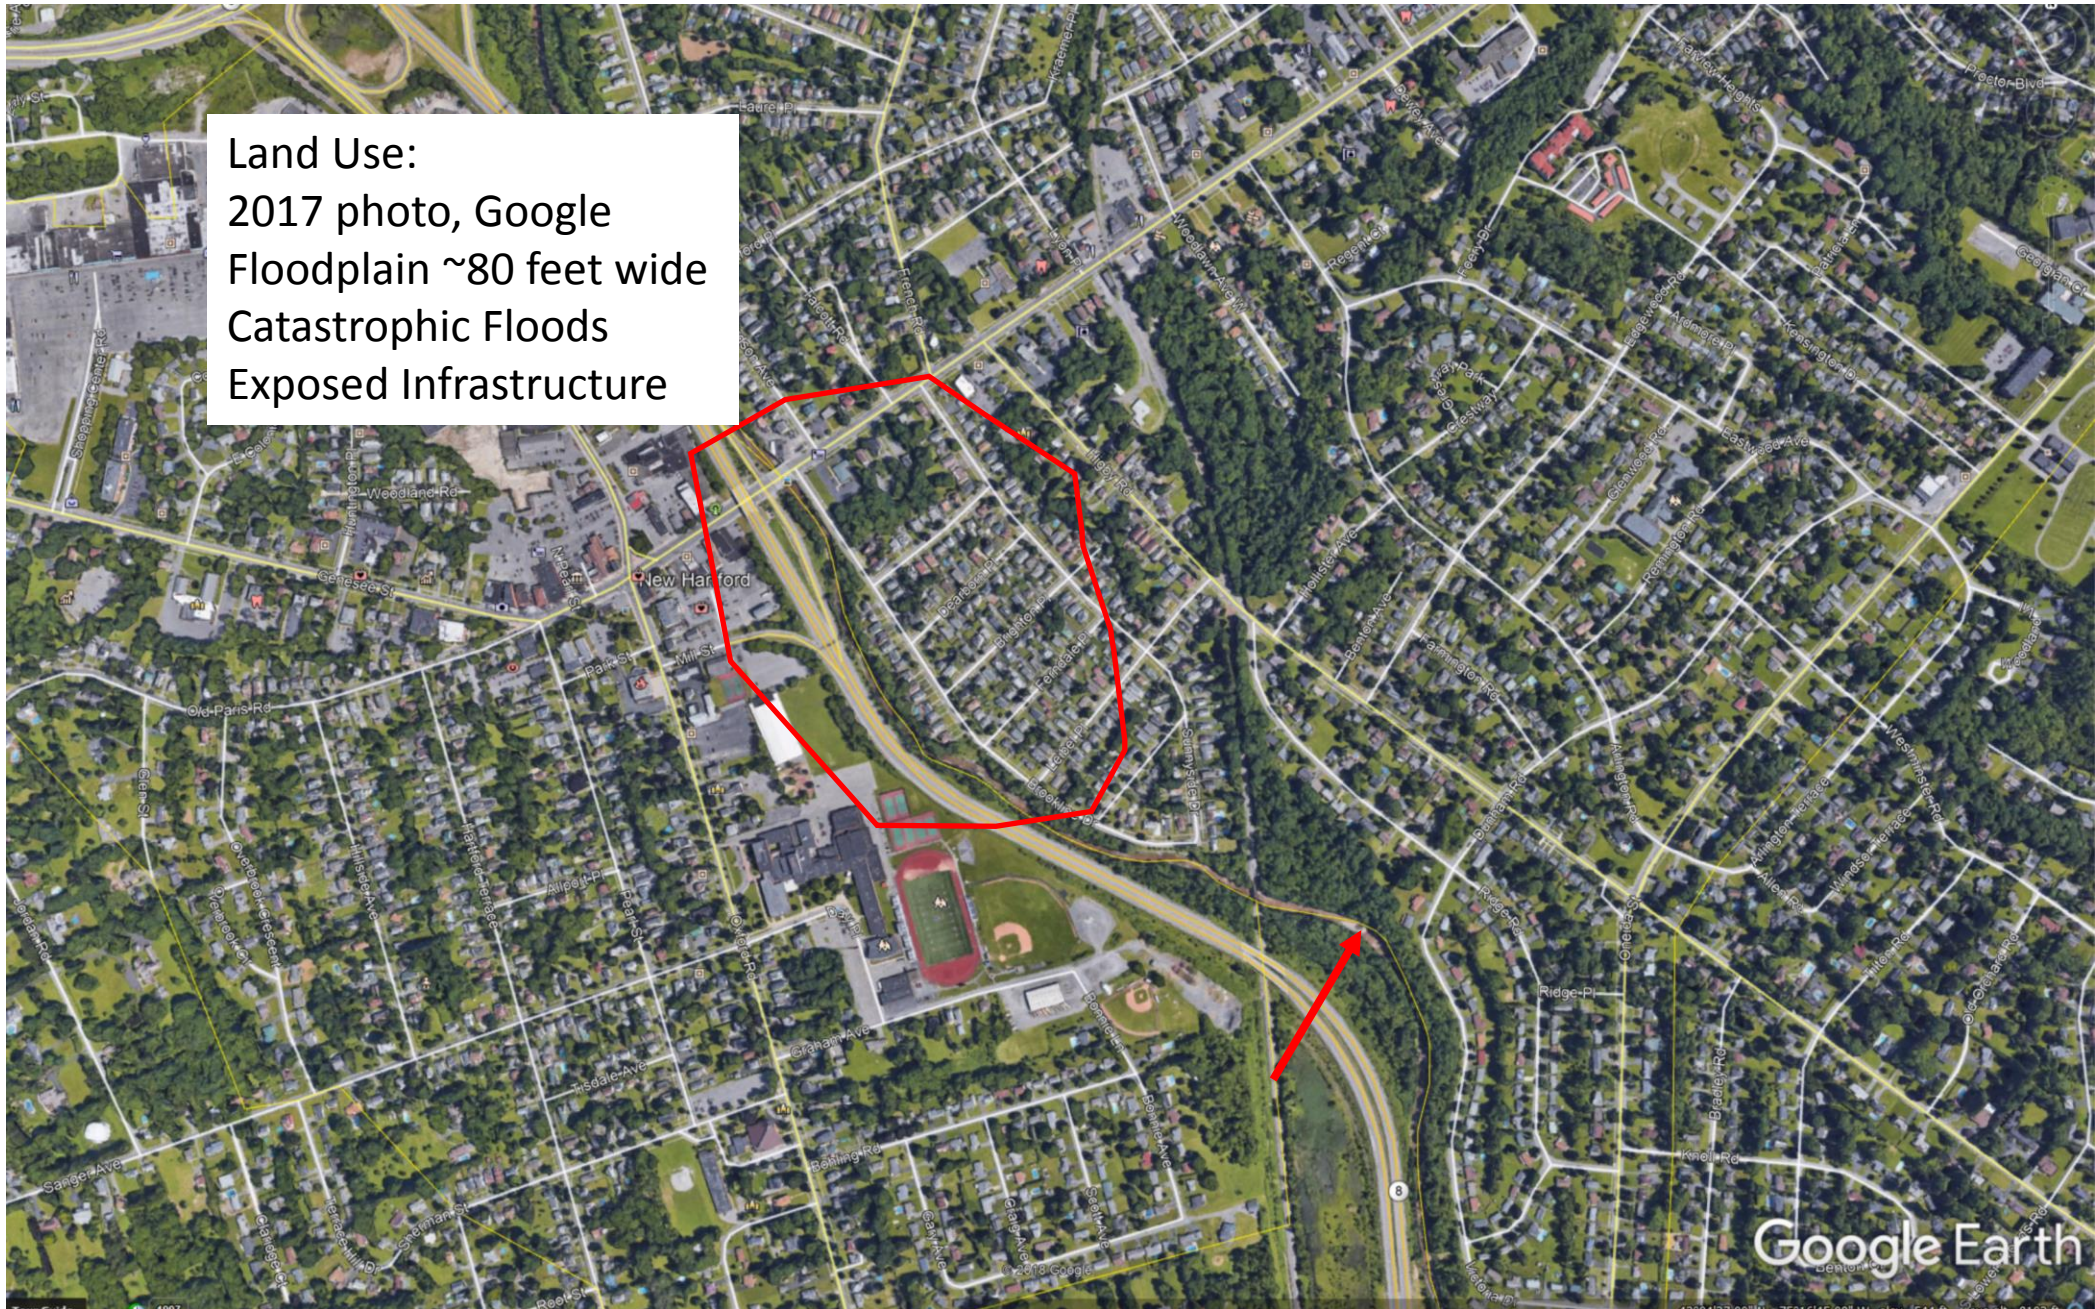
Land Use:  
2017 photo, Google  
Floodplain ~80 feet wide  
Catastrophic Floods  
Exposed Infrastructure

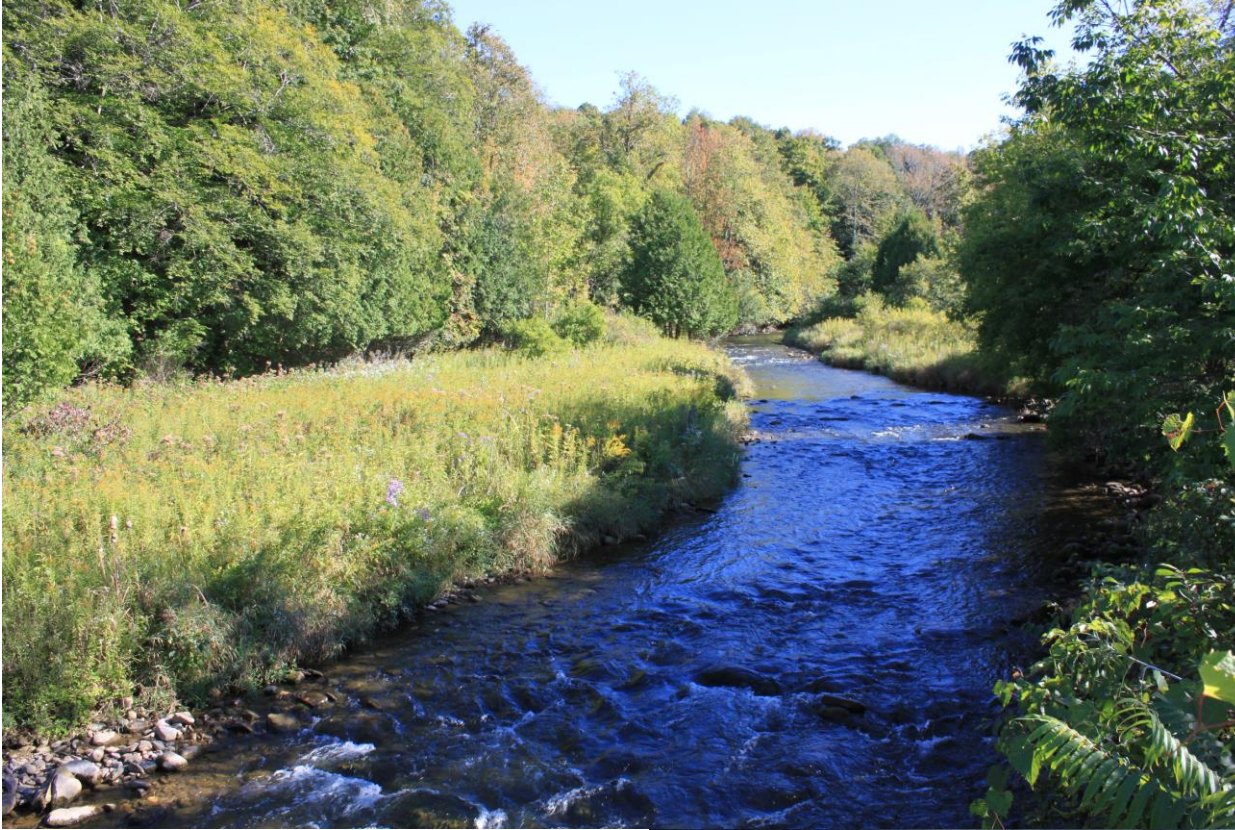
Reference Reach of C3

Summer Flow

Good Veg

No Development Pressure

Properly sized infrastructure

Bankfull at Spring Runoff

Dimensions remain stable.

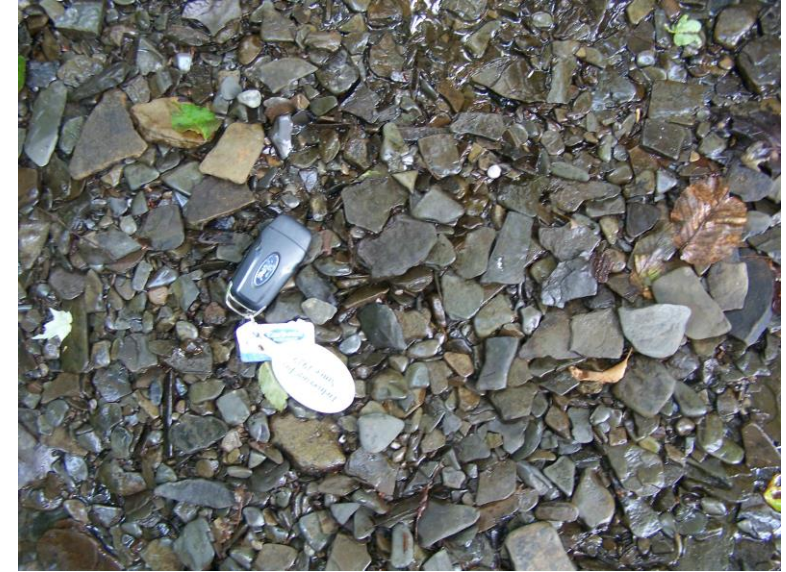
Longitudinal profiles,  
cross sections at riffles,  
Pebble counts

Document the existing conditions to help determine how to repair the channel.

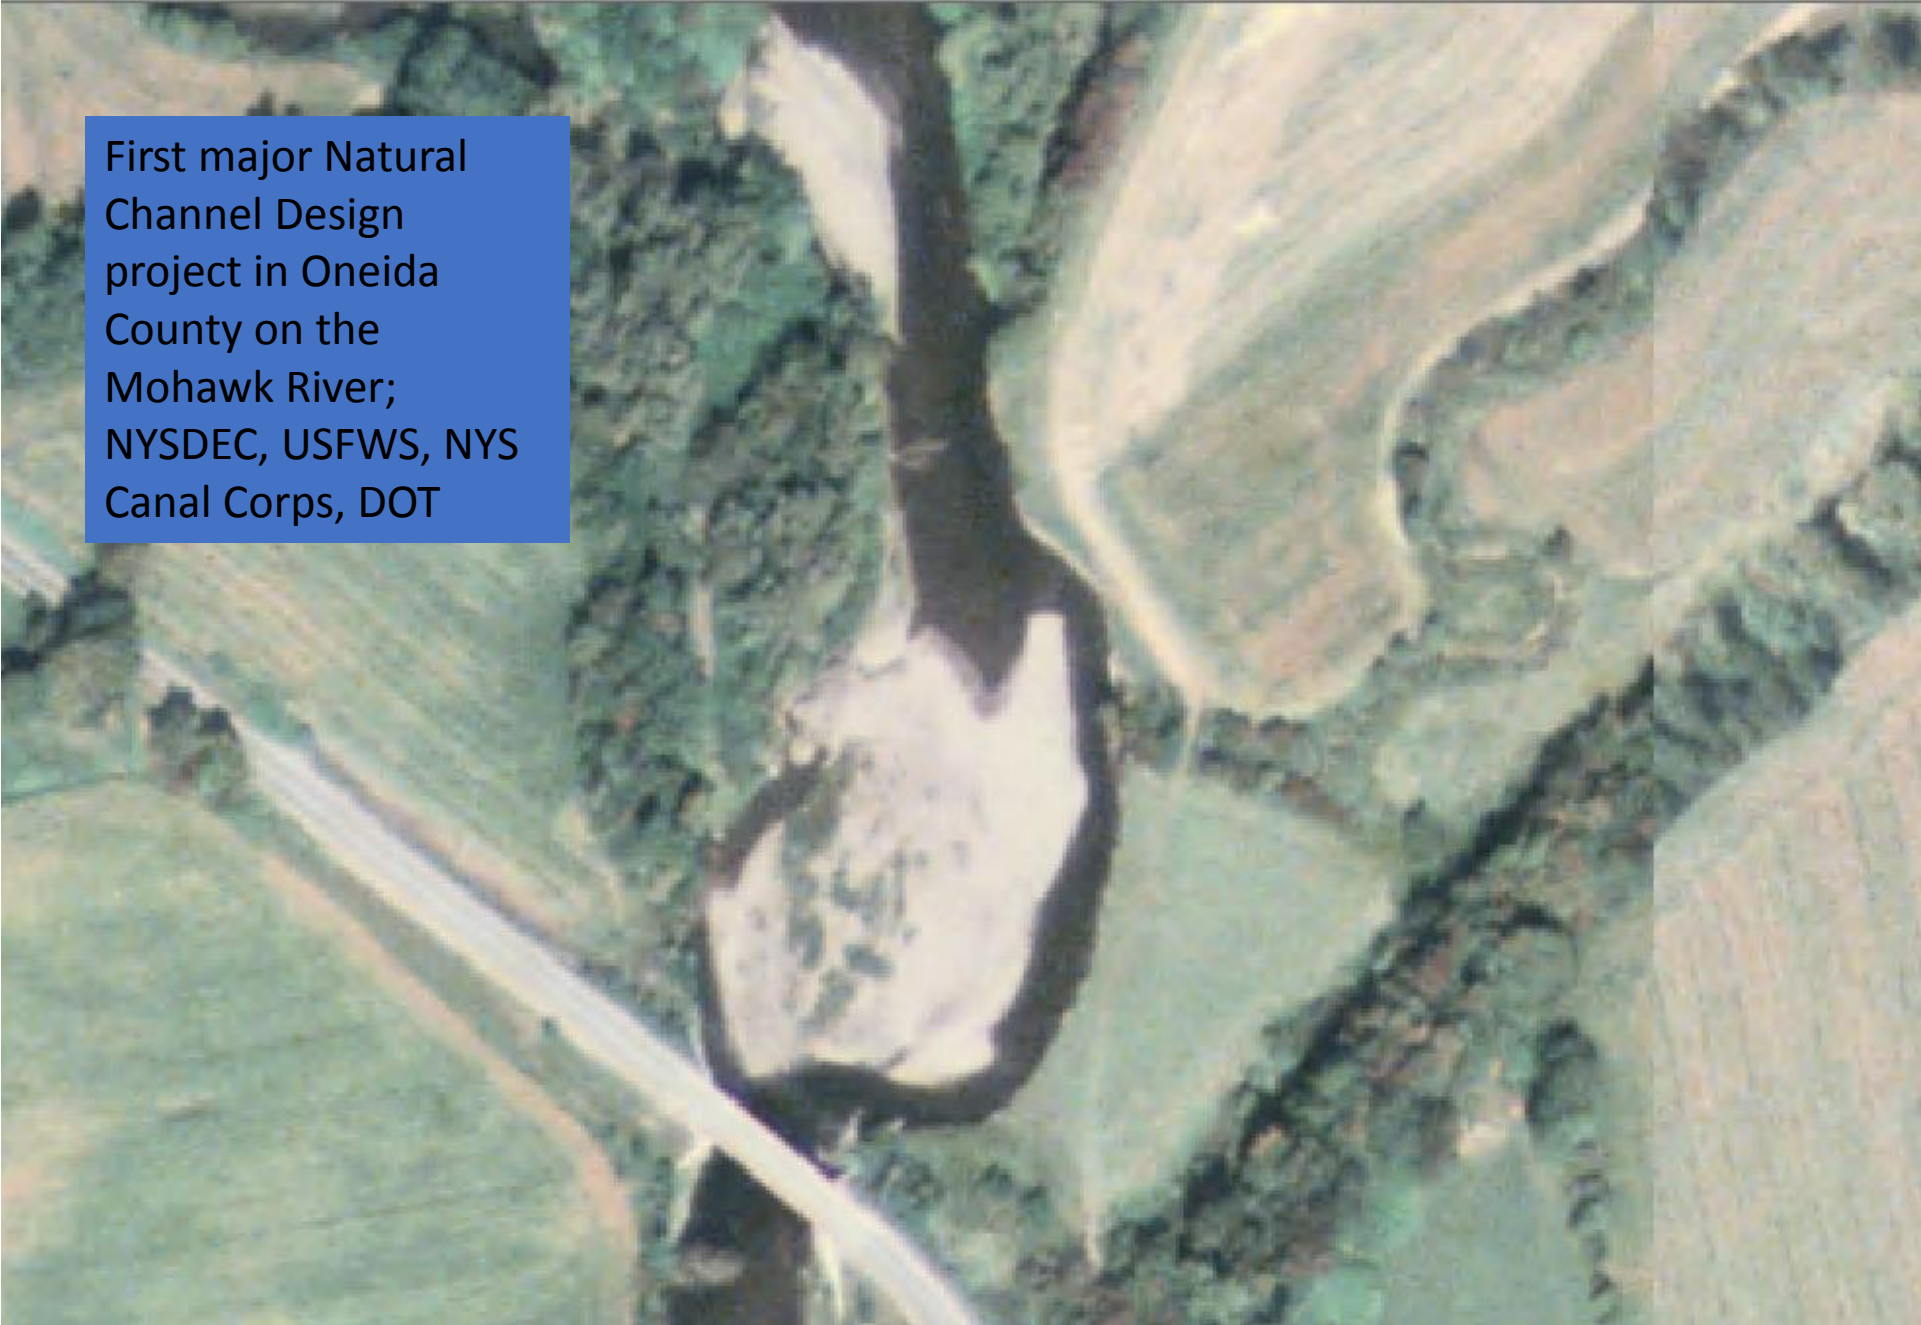
An aerial photograph showing a river flowing through a landscape. A bridge crosses the river, and the surrounding area includes fields and forested regions. The river's path is visible, showing some deviation from a straight line.

2008 GIS Aerial image, Stokes Westernville Road (bridge approx 130' span); River is almost 200 feet from path in mid 1990s. Possibly caused by gravel removal.

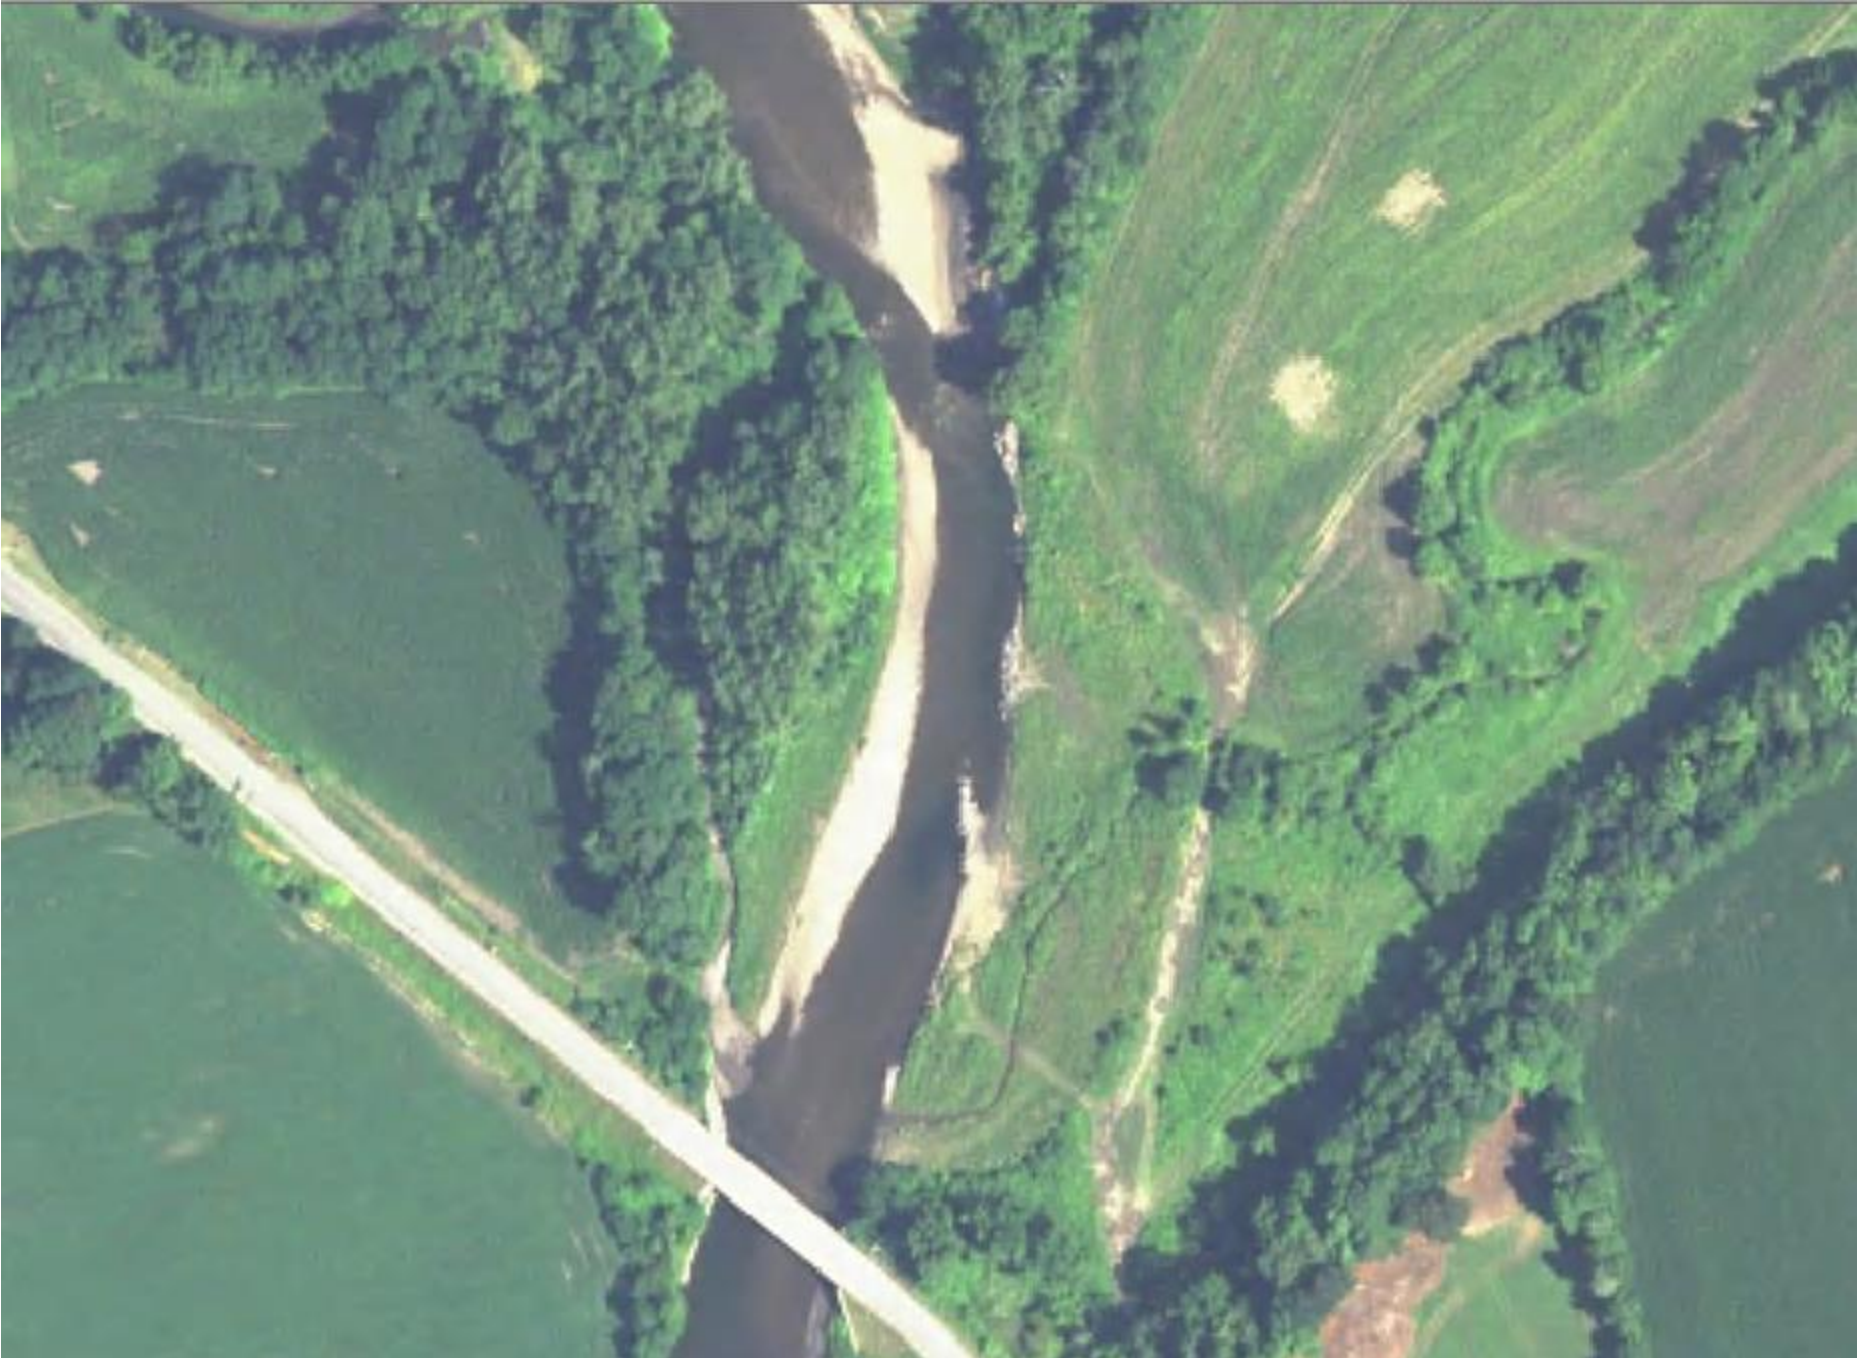
2015 GIS Aerial Stokes Westernville project, fully vegetated and stable.

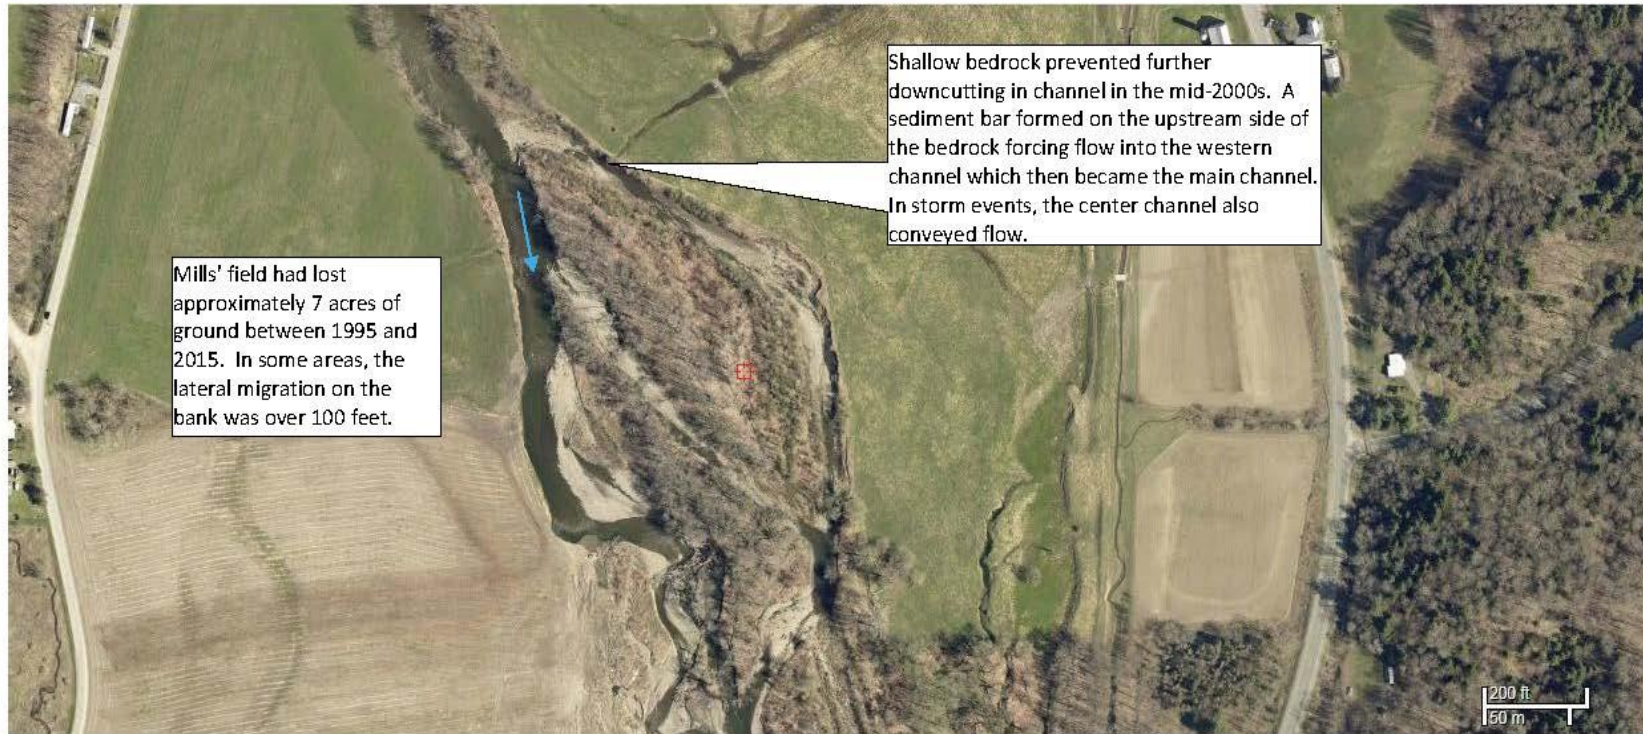
2015 Mills site

Mills' field had lost approximately 7 acres of ground between 1995 and 2015. In some areas, the lateral migration on the bank was over 100 feet.

Shallow bedrock prevented further downcutting in channel in the mid-2000s. A sediment bar formed on the upstream side of the bedrock forcing flow into the western channel which then became the main channel. In storm events, the center channel also conveyed flow.

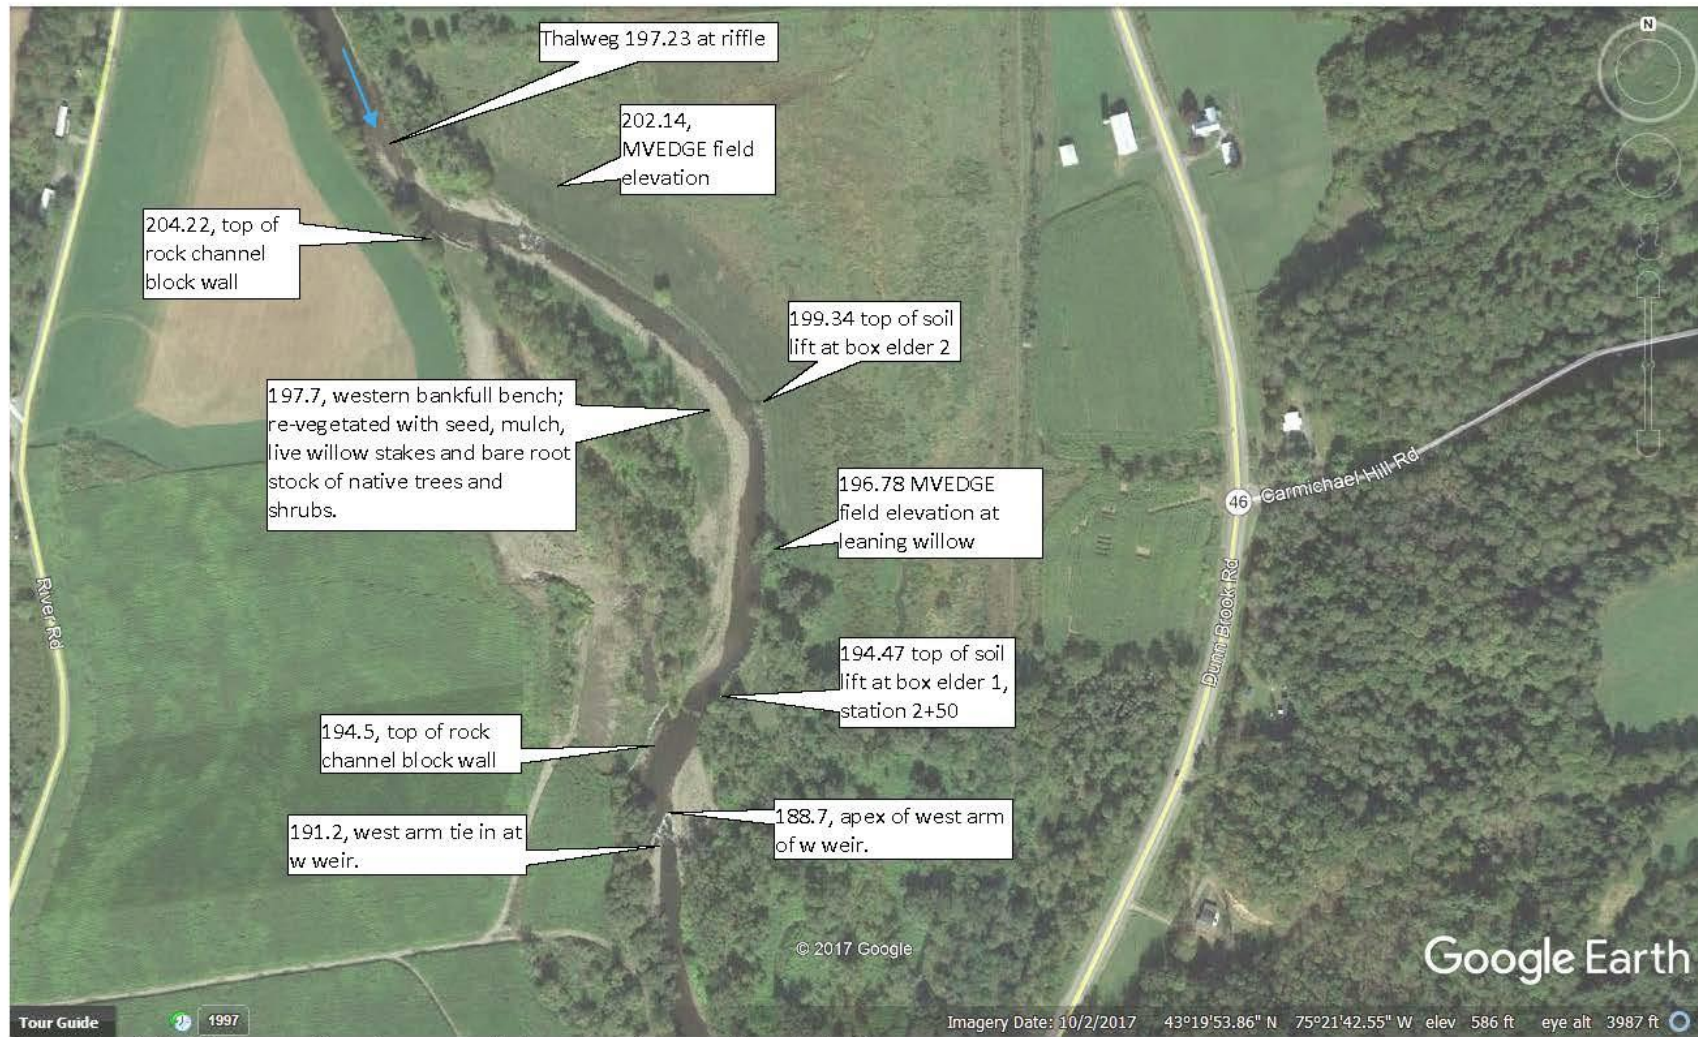
Google Earth 2017 imagery, Elevations; overall channel grade approximately 0.4%.

Rock adds extra insurance  
to logs especially during  
high flows.

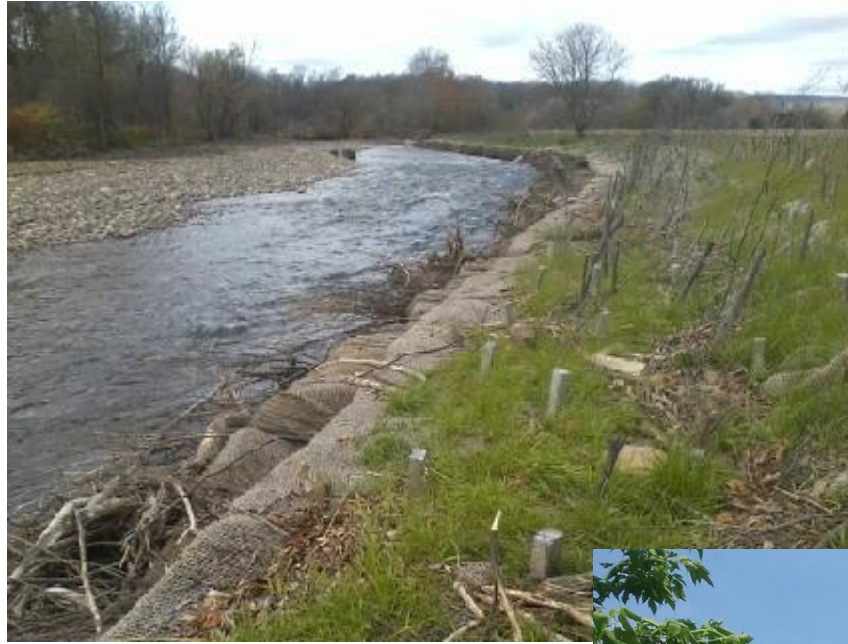
Not just water to consider...

Ice

Low Gradient

High Bedload

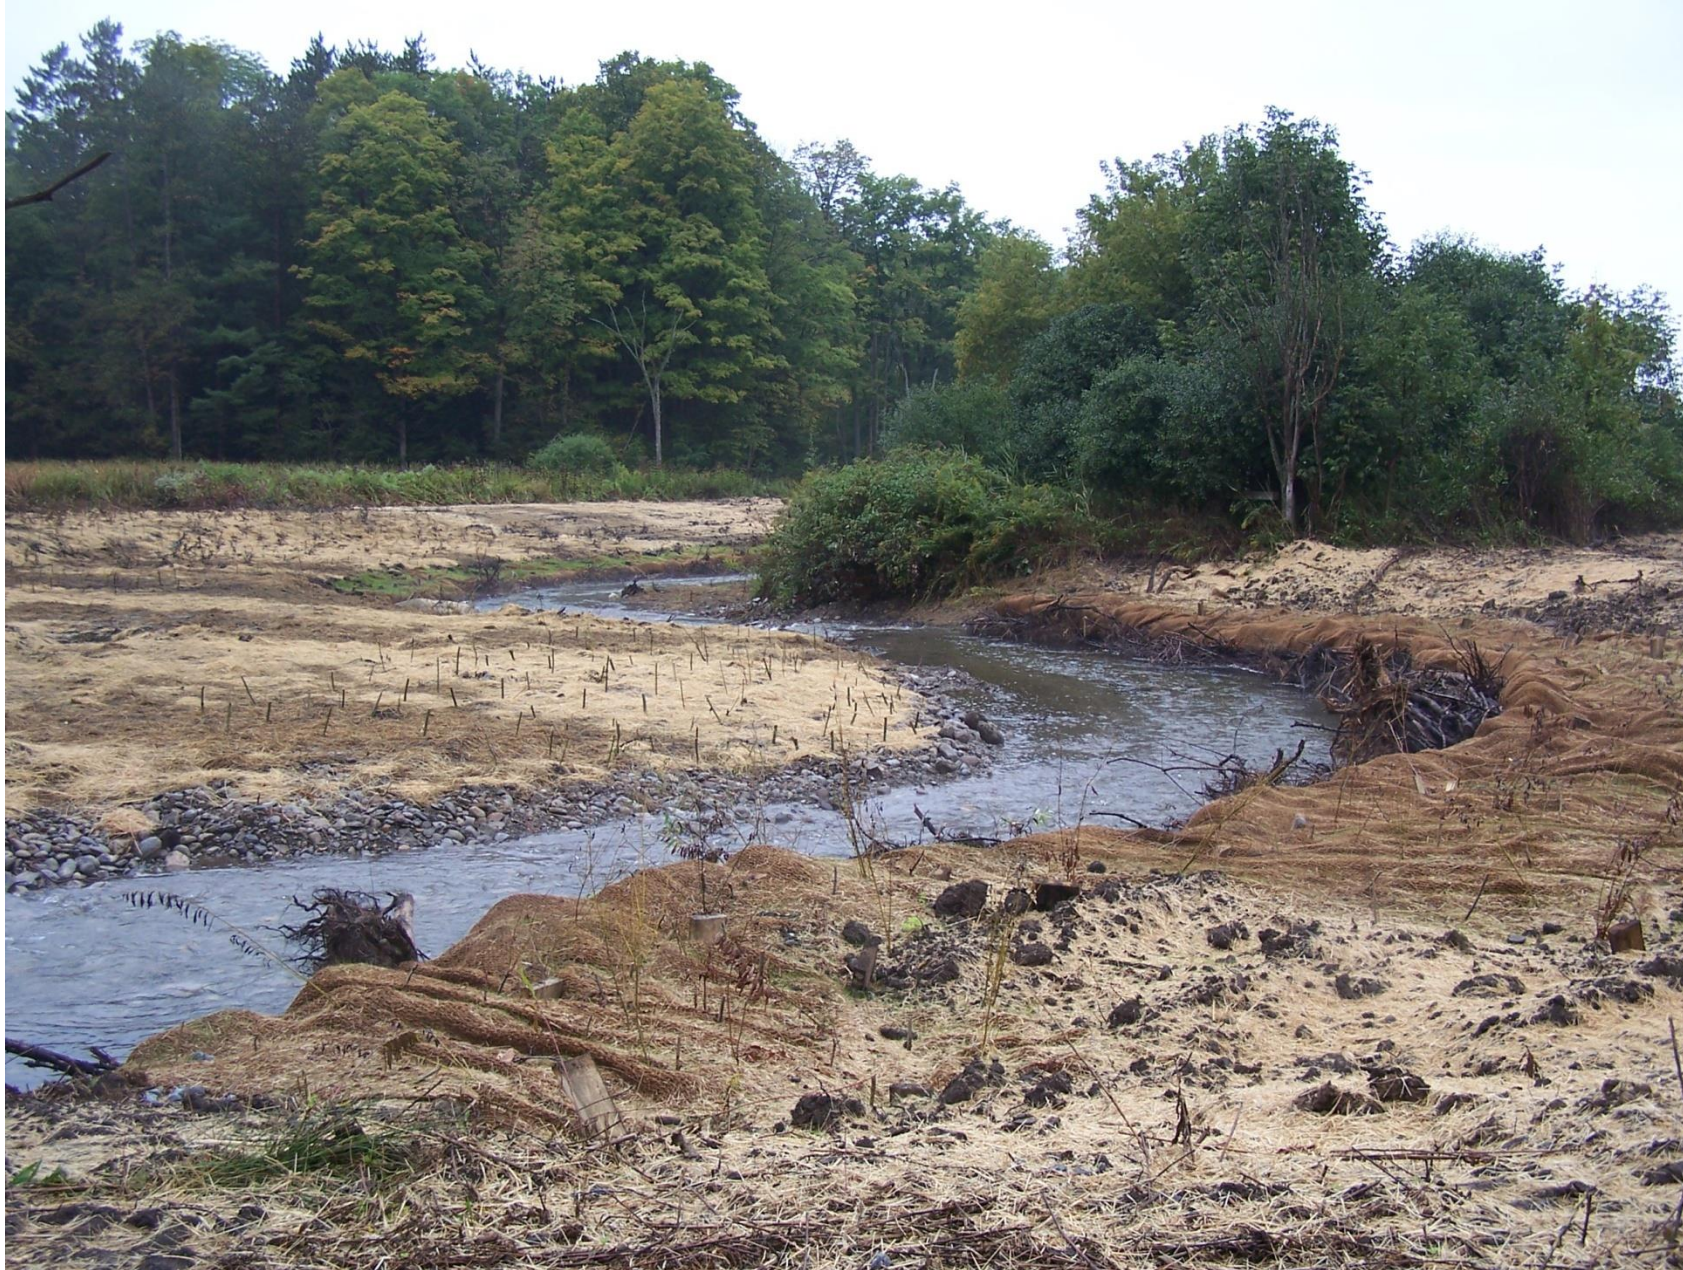
Facing downstream from the meander toe wood in September of 2016 approximately 1 week post construction.

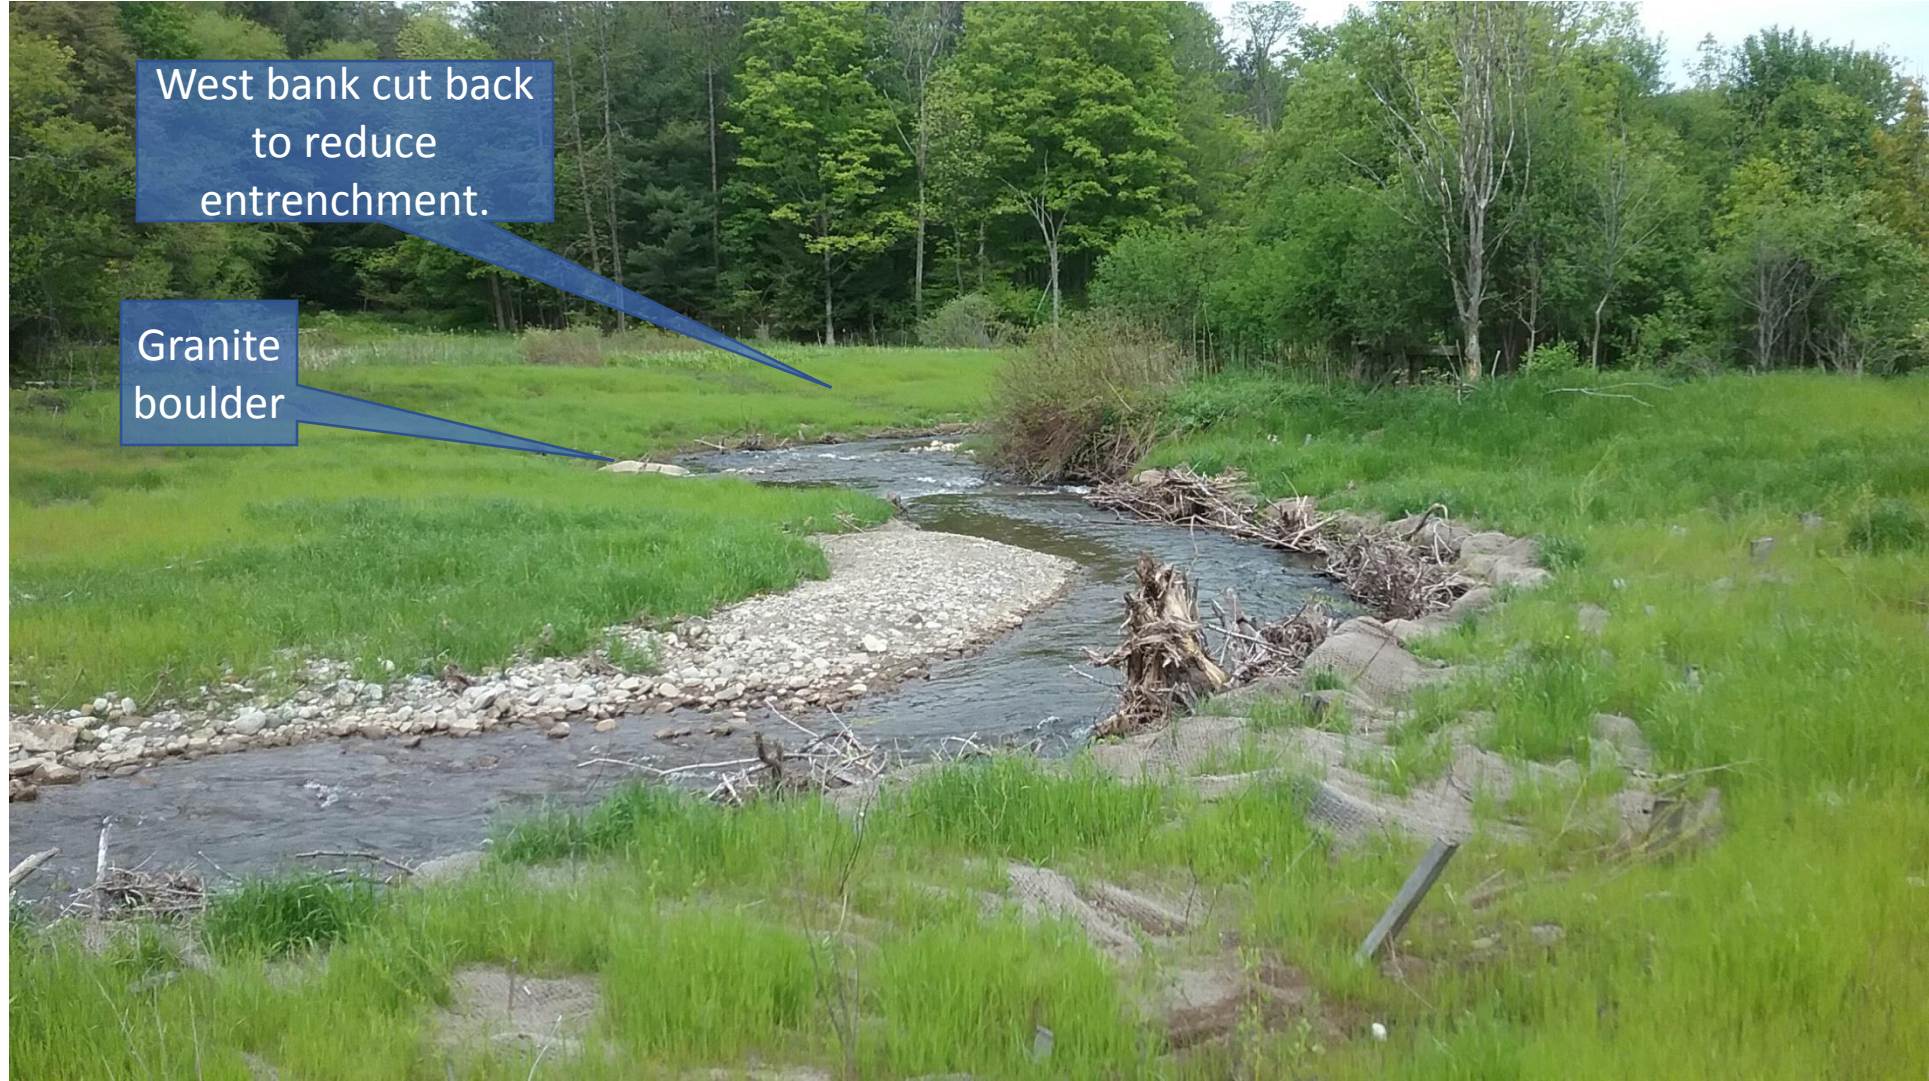
May, 2017: Facing downstream from the upstream extent of the toe wood at the meander

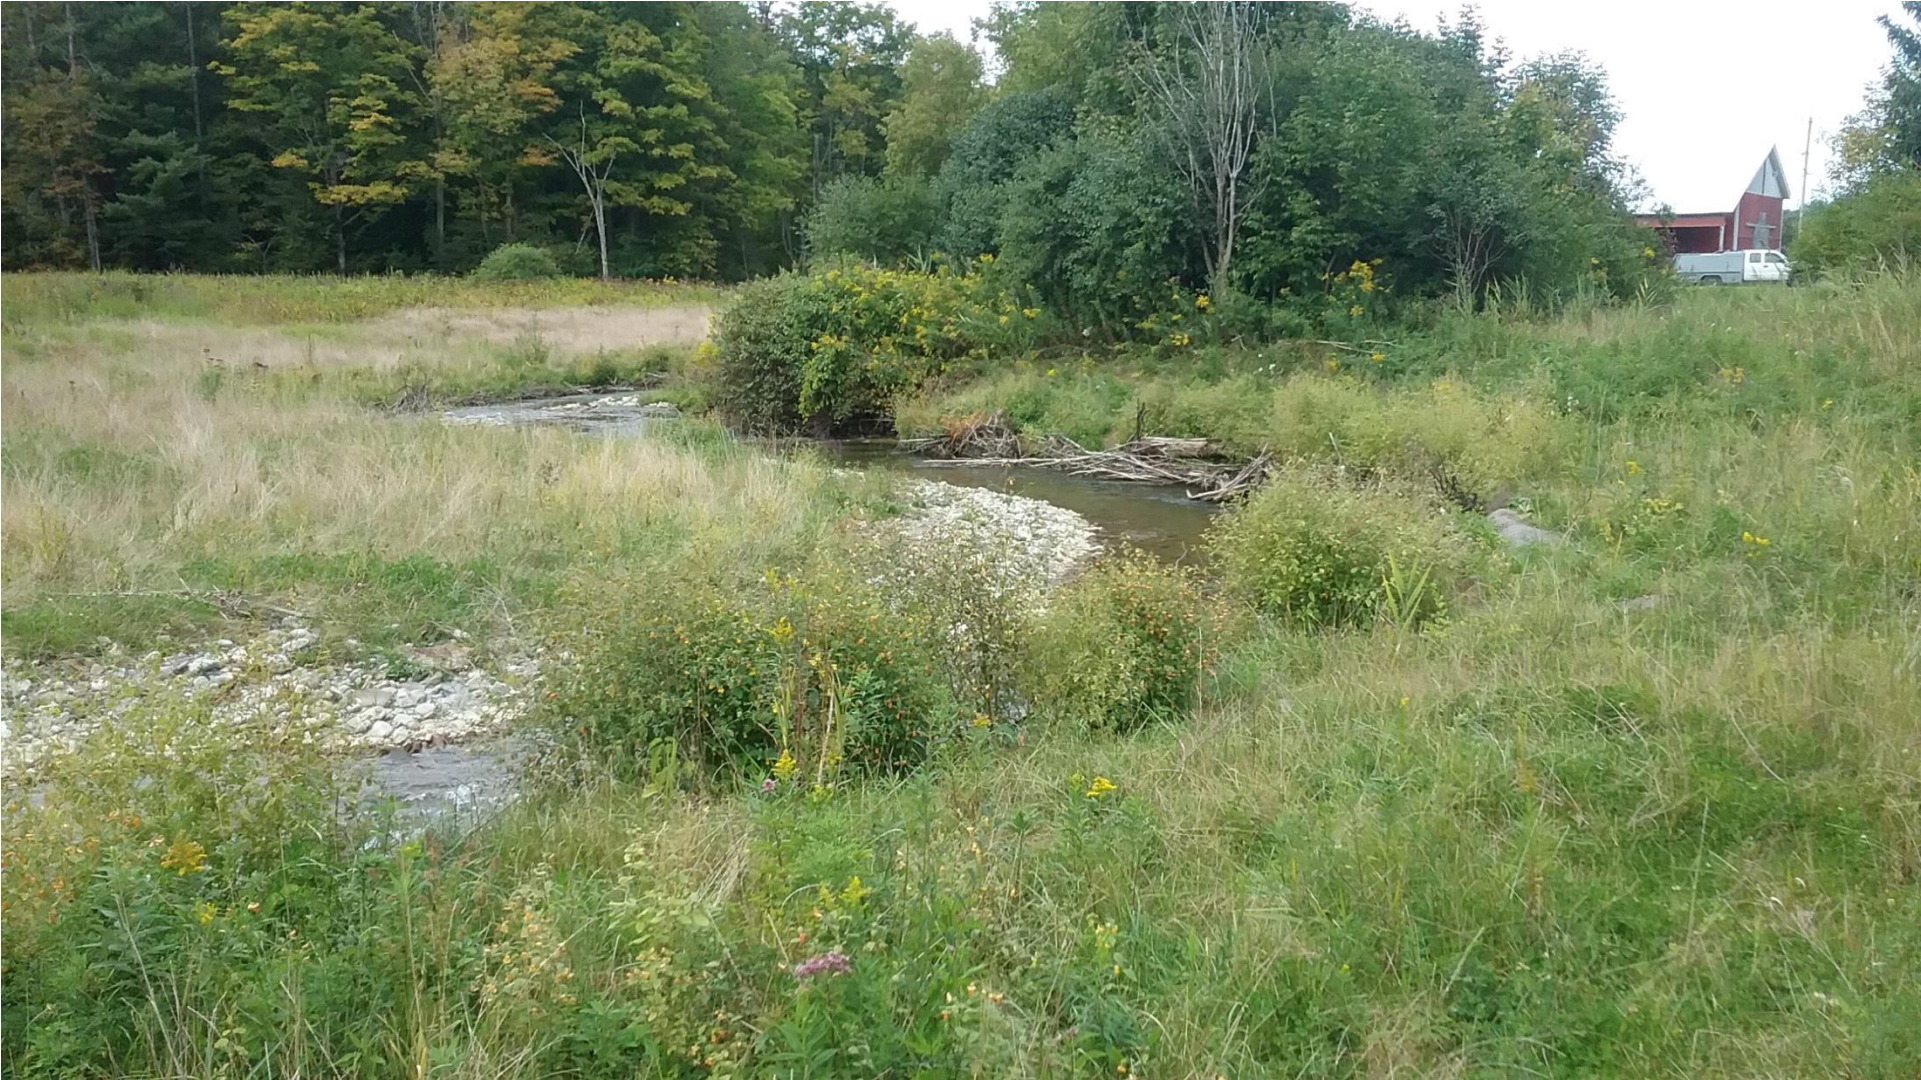
Sept, 2017: Facing downstream from the upstream extent of the meander toe wood

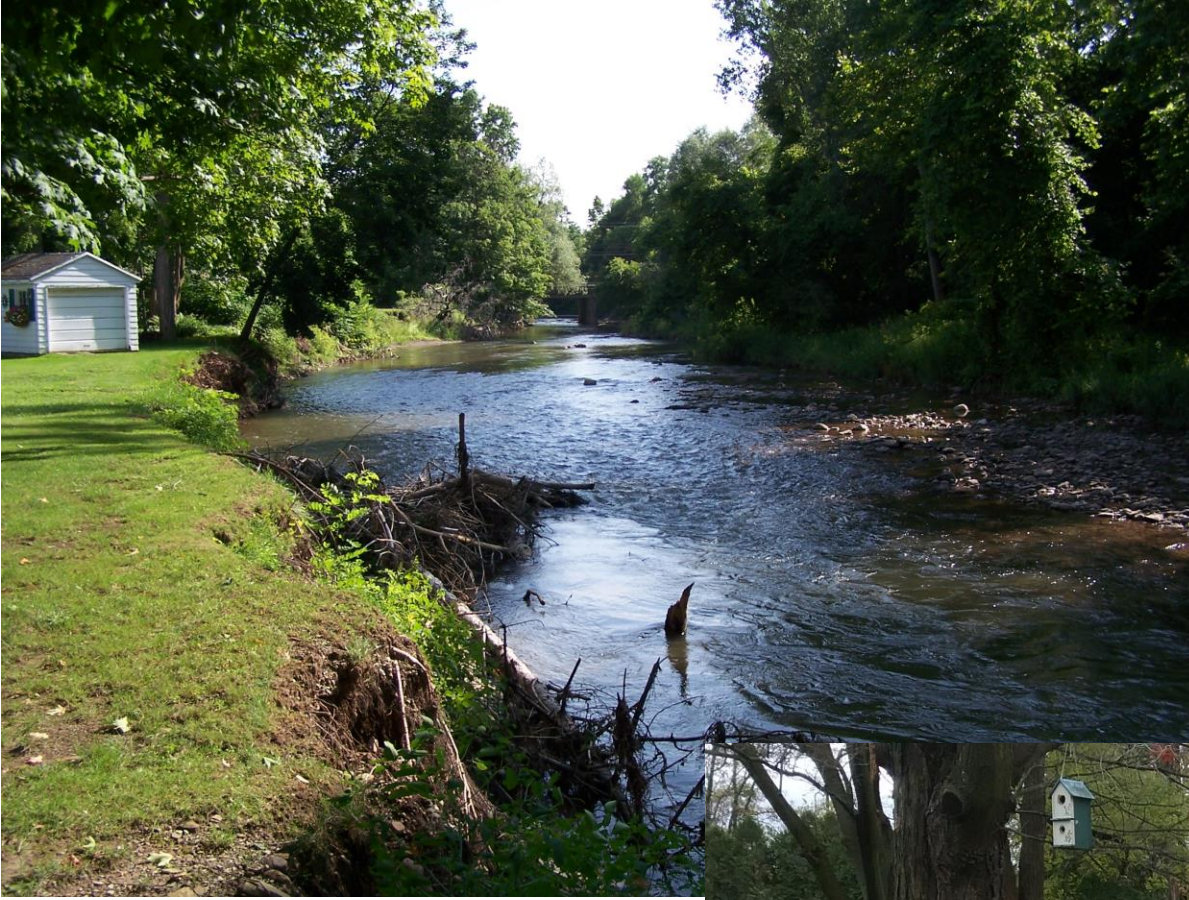
Water overtops this bank by up to 1.5 feet in large events but toe wood held. Minor repairs were needed on the upper bank after 7.1.17 storm.
