## **Oneida County SWCD**

# Stream Restoration in Oneida County

First major Natural  
Channel Design  
project in Oneida  
County on the  
Mohawk River;  
NYSDEC, USFWS, NYS  
Canal Corps, DOT

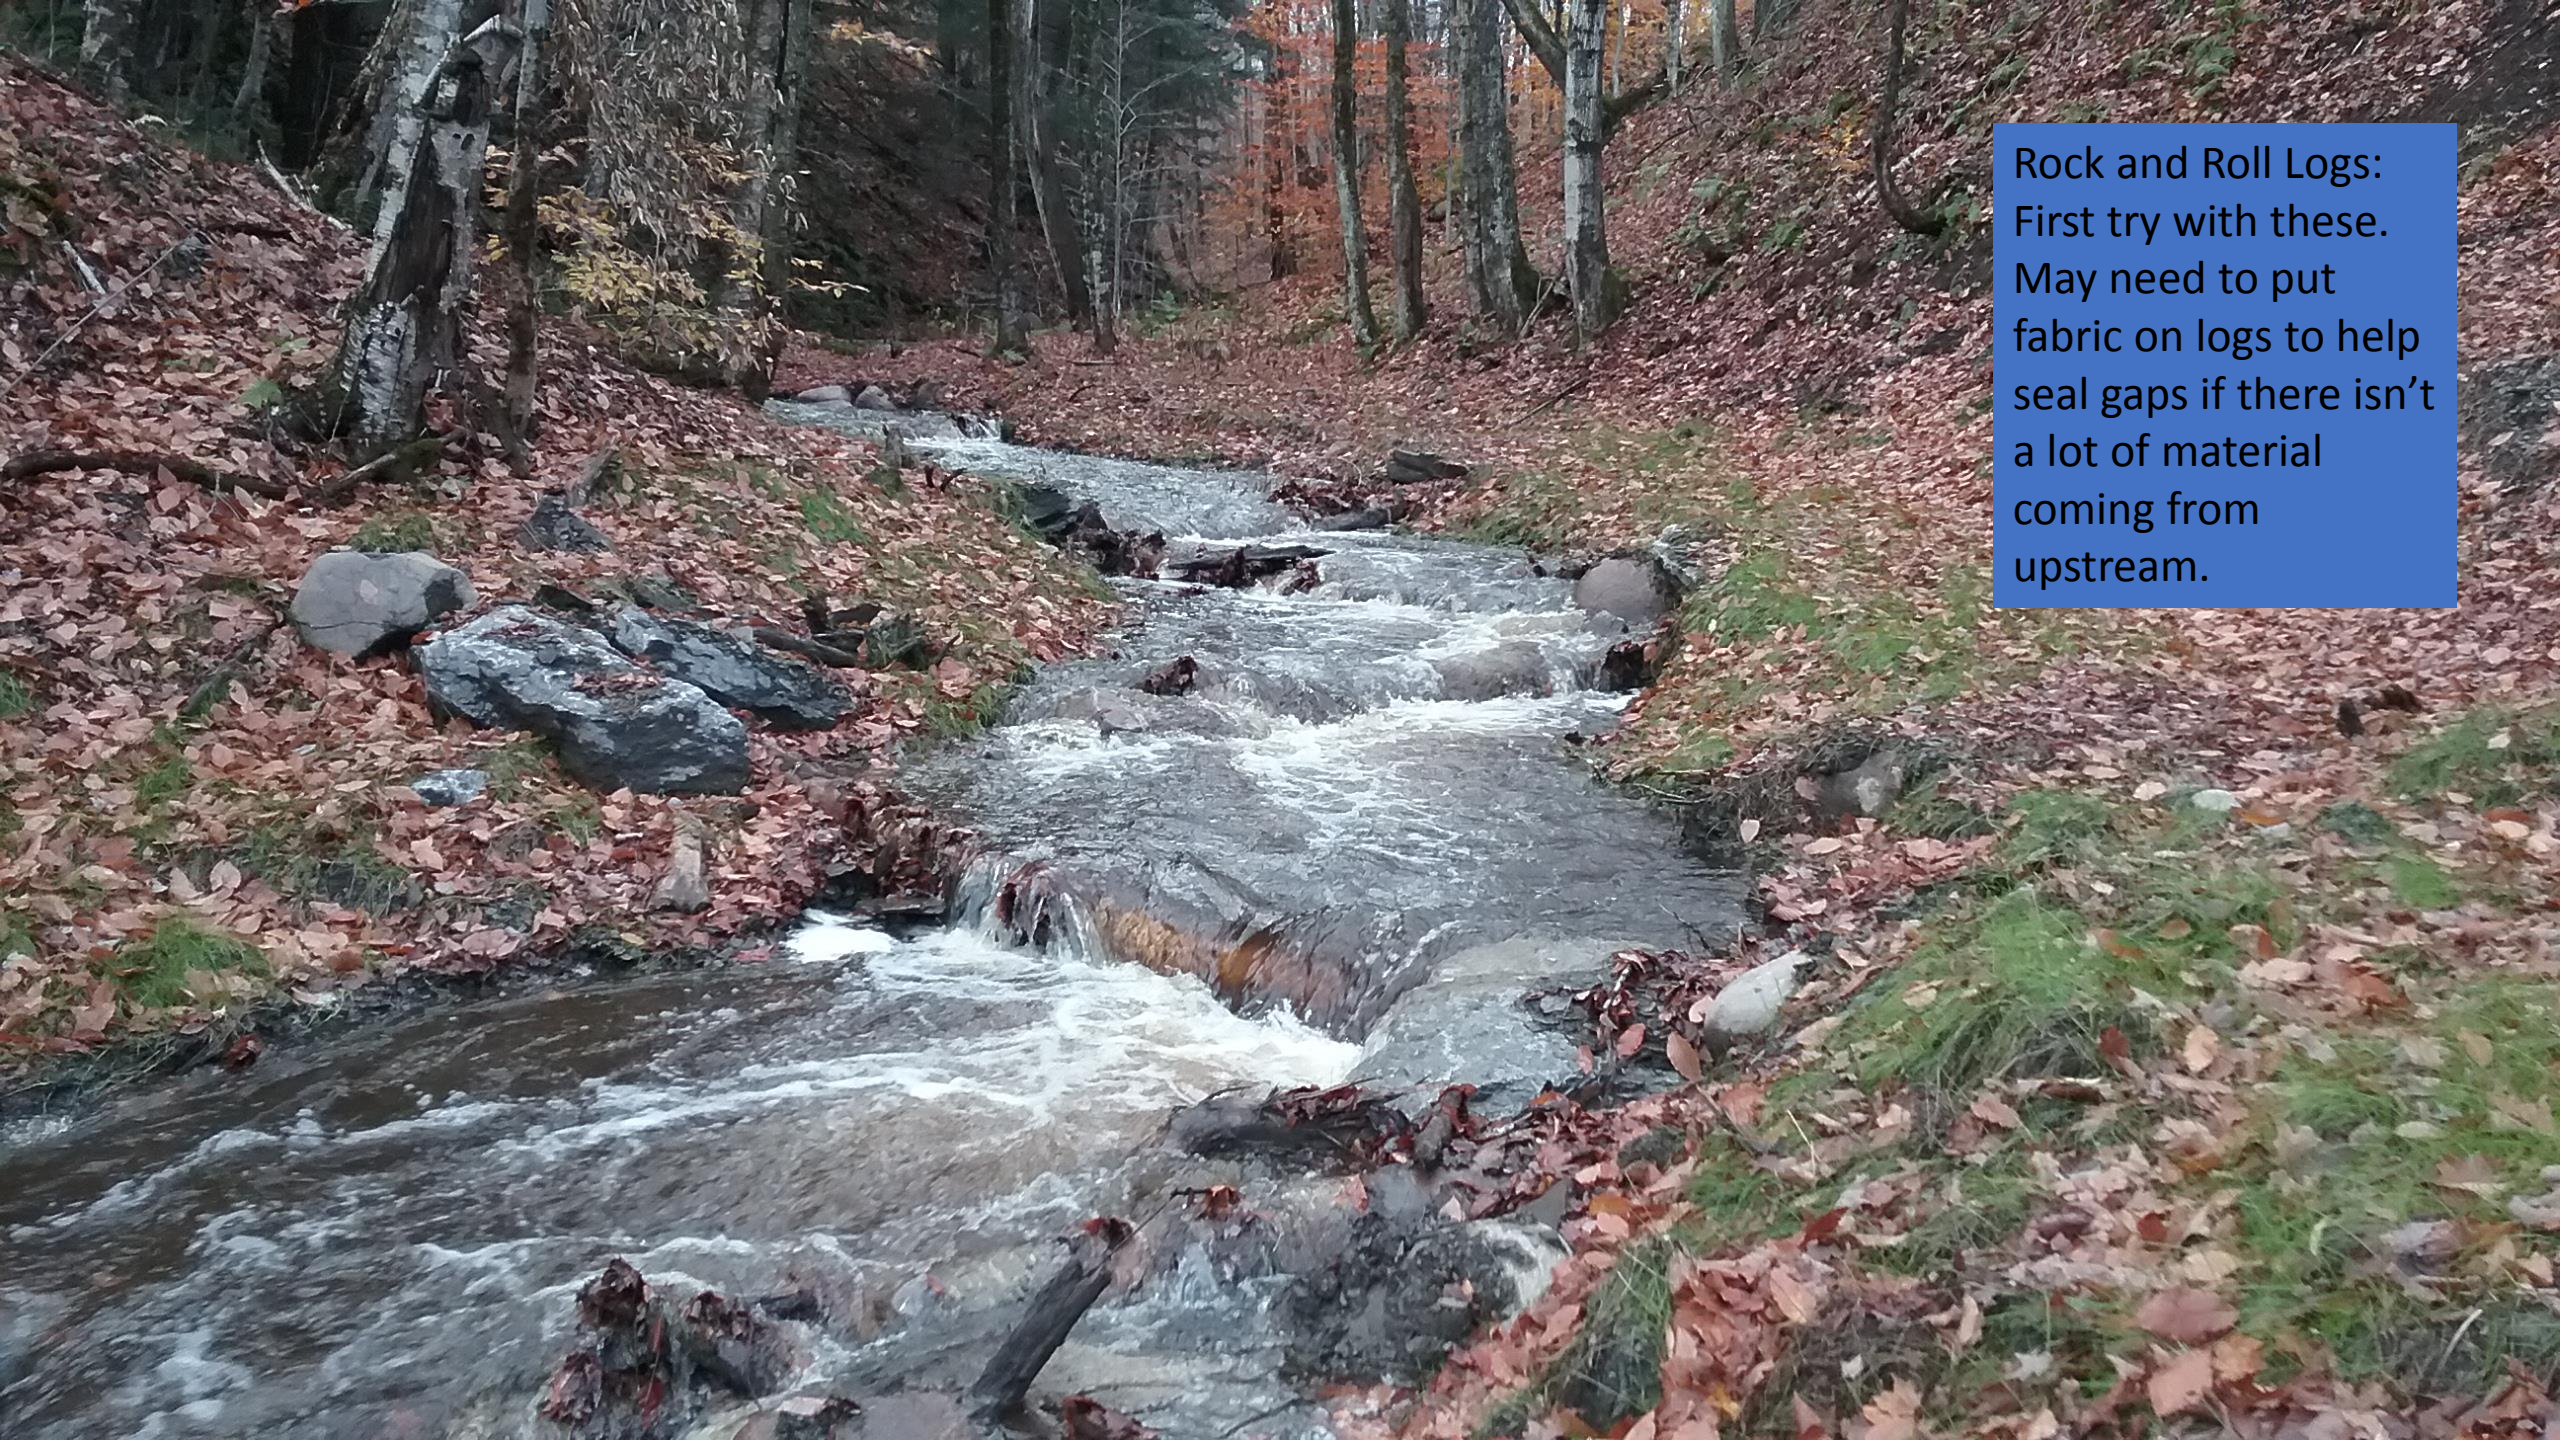
Rock and Roll Logs:  
First try with these.  
May need to put  
fabric on logs to help  
seal gaps if there isn't  
a lot of material  
coming from  
upstream.
