Case Studies in Natural Channel Design

Black River Watershed Conference
June 12, 2018 • Camp Türk

Caitlin Stewart
Conservation Educator

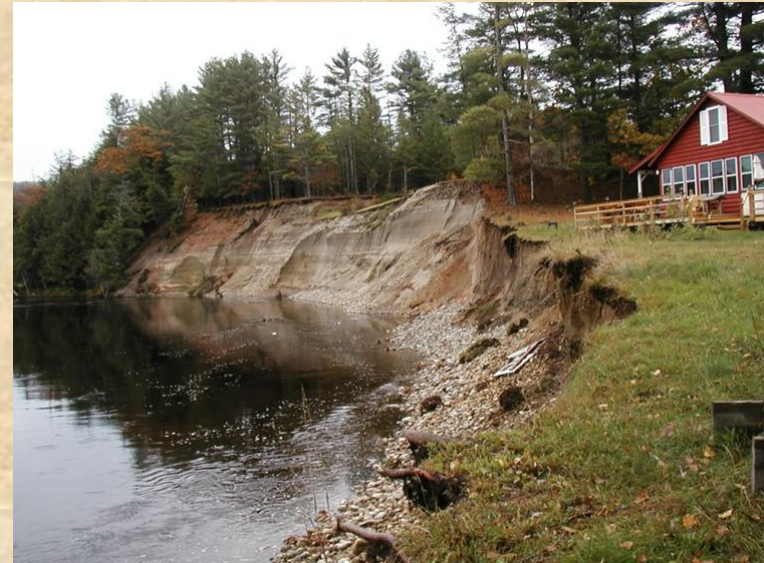
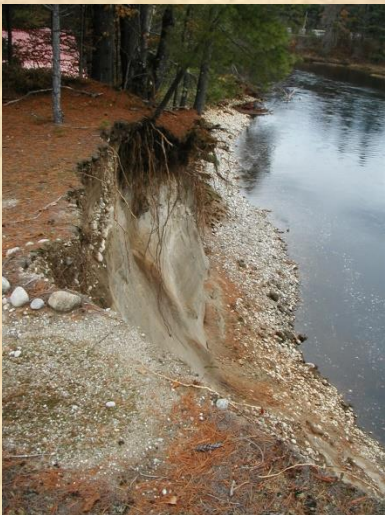
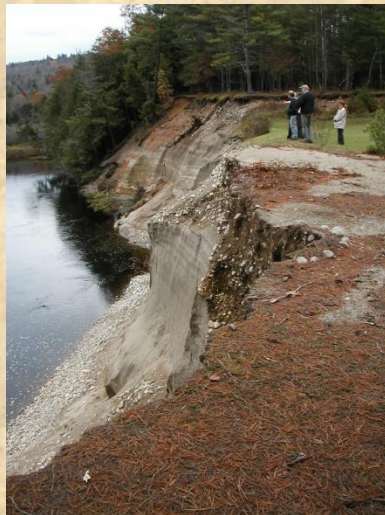
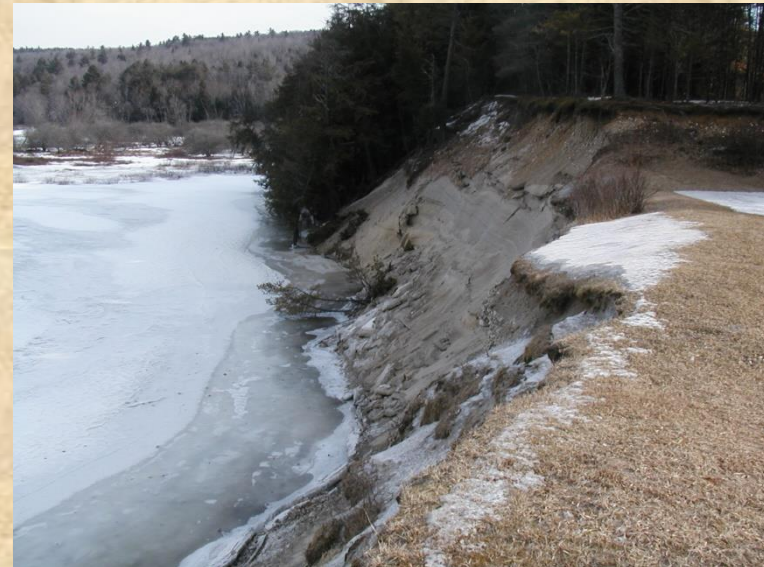
Cave Banks

- 400 ft X 70 ft
- Irene - 2,500 yd³
- Erosion – property, habitat
- River undercut toe
- Erosion from top down

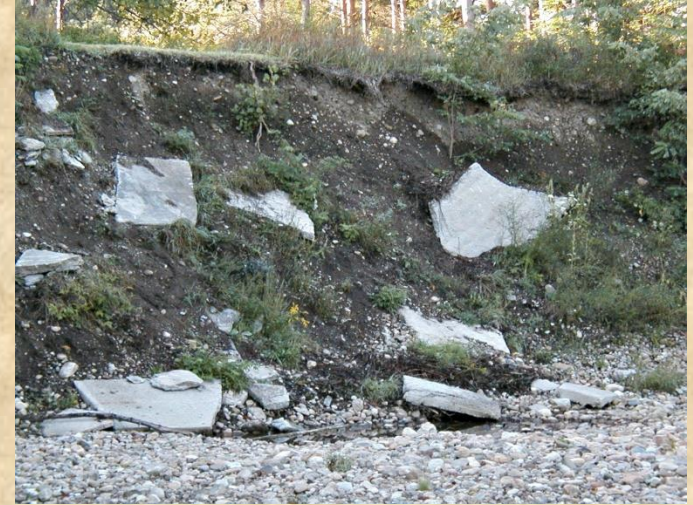
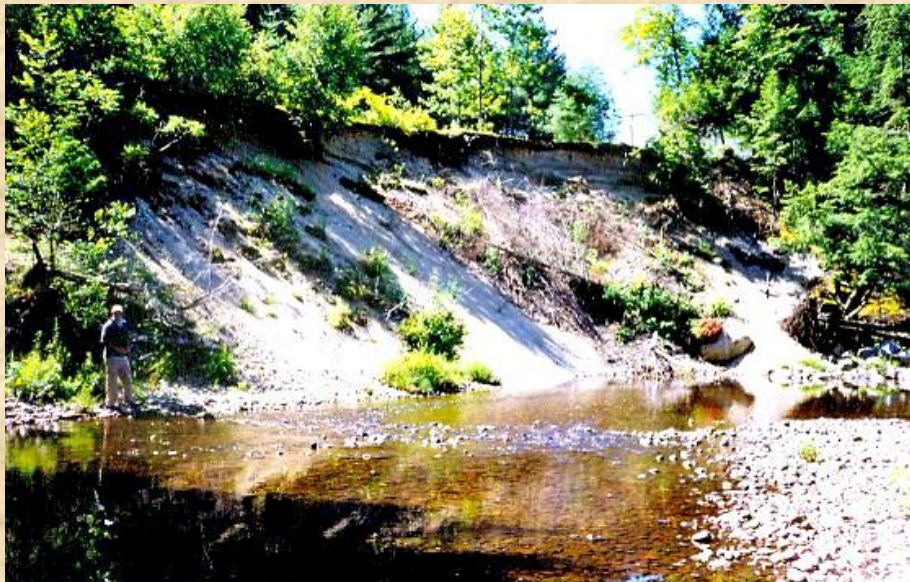
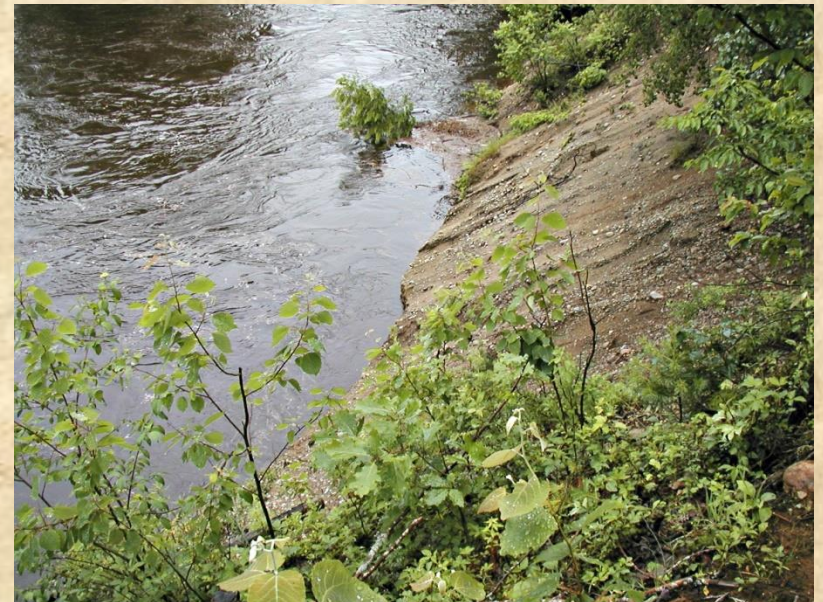
Griffin Road

- 300 ft of 30 ft riverbank
- ↓ 700 ft in 8 mi
- Erosion – infrastructure, utilities, property

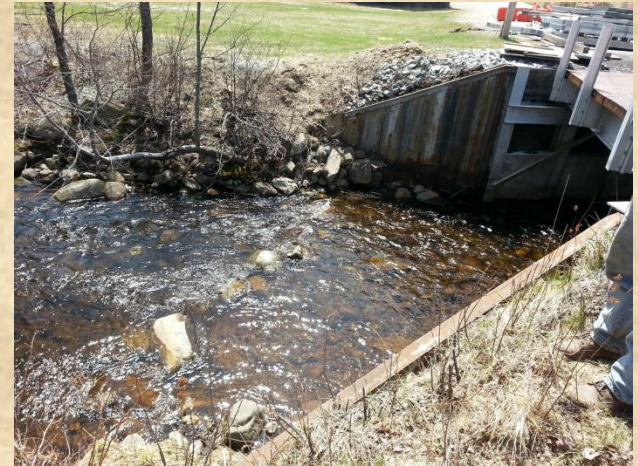
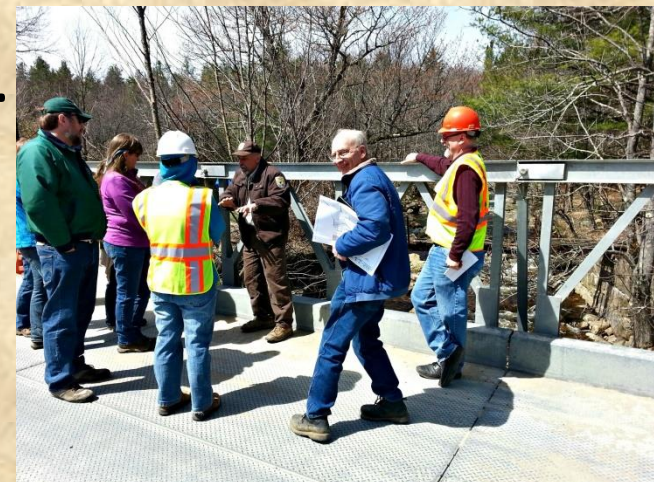
Browns Brook Bridge

- Tropical Storm Lee & Hurricane Irene
- Weakened bridge abutment
- Partnership
 - USFWS
 - Hamilton County Highway Dept.
 - HCSWCD
